Safety Inspection Report

Annual Inspection

Chadlington Playground

19 August 2024

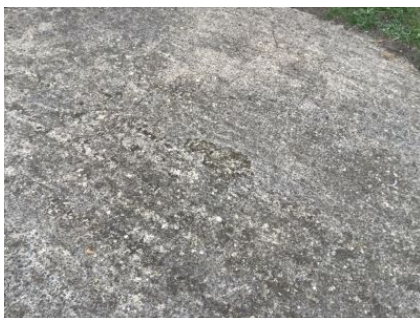
Basketball Post

Surface has holes in it.

Repair.

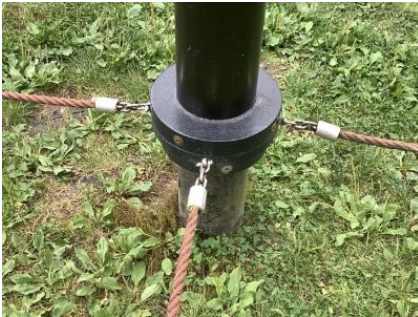
Climber - Rota Web

The supporting components should be dismantled and inspected according to the manufacturer's instructions. This will need doing on a regular basis, as defined by the manufacturer. This can lead to a high risk if no action is taken.

Dismantle for internal inspection of bearings as unit is loose at bottom turning mechanism.

Dismantle and inspect according to manufacturer's instructions.

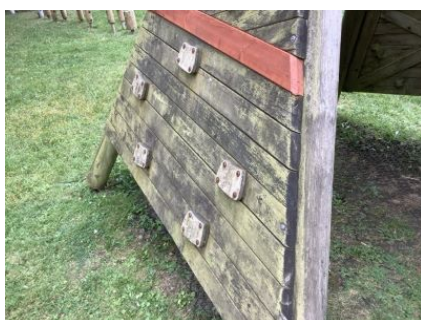
The equipment is dirty or algae covered.

Clean off.

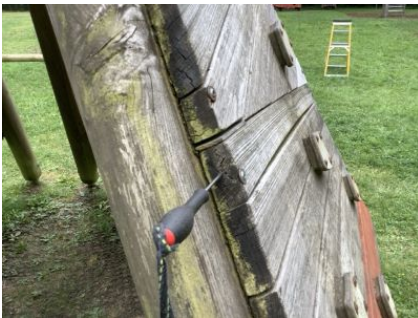
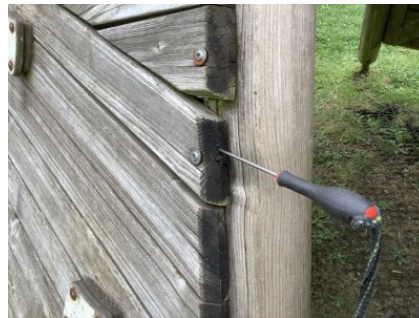
Timber is decayed.

Check on a routine basis.

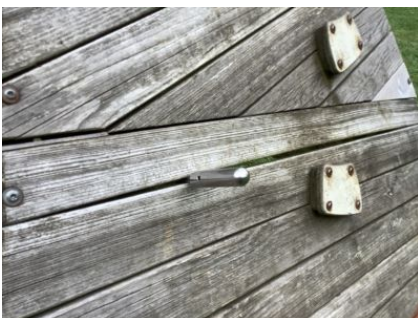
Finger entrapment.

Finger entrapment between boards. Modify.

Read the notes for further action.

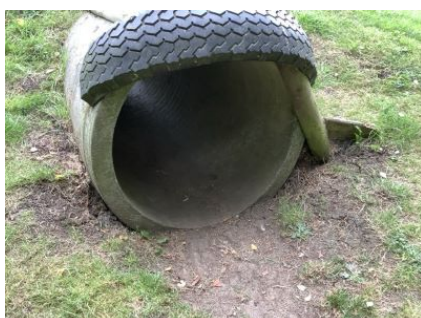
Mound Tunnel/Concrete Tubes

These items have become noted as being associated with accidents. We recommend padding each end of the tube to reduce the possibility of children running into the edge. Padding can be achieved by securing a strip rubber to the ends, or fitting a rubber tyre split in half vertically. Removal should also be considered if padding is not available.

Add padding to the end of the tube.

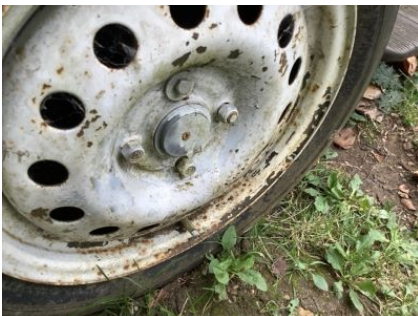
Play Car

Paintwork is in poor condition.

De-scale back to good base material and coat with lead free paint, using appropriate precautions. Repairs may be necessary where corrosion is severe.

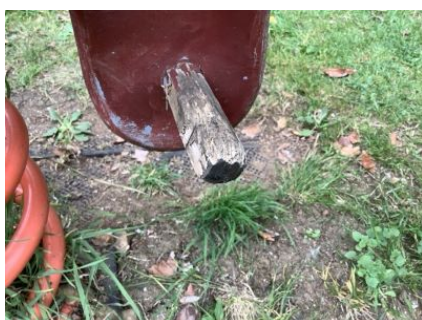
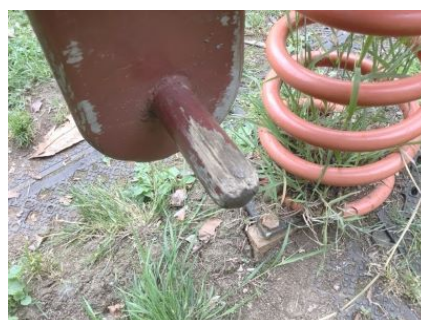
Timber is not in good condition.

Repair.

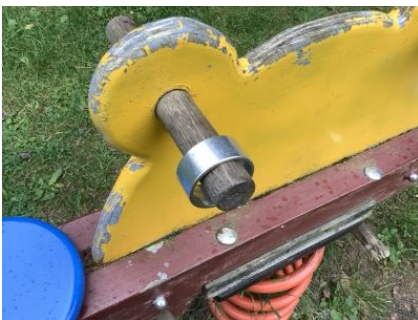
Protruding handles / foot rests.

The unit was installed prior to the publication of the current standards. There is no requirement to make retrospective changes.

Monitor.

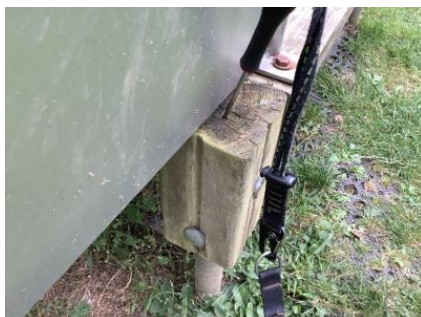
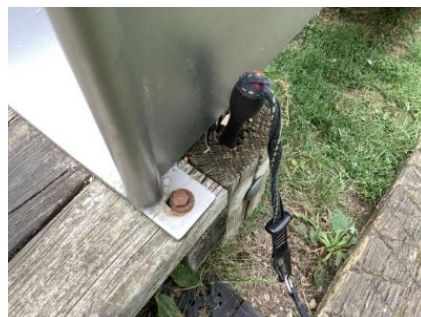
Timber is decayed.

Check on a routine basis., Replace affected parts.

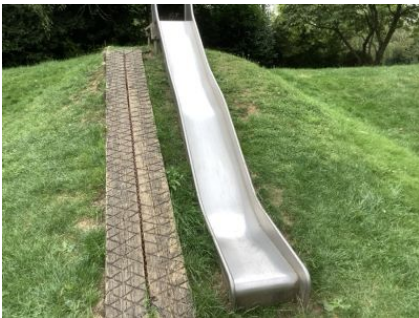
The free space and / or falling space contains obstacles or equipment parts that are not permitted.

Chain pull and surface edging. Monitor.

Read the notes for further action.

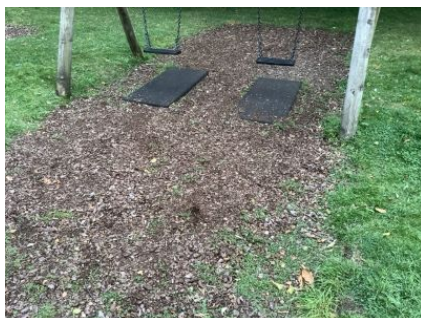
Surface is compacted or displaced.

Rake and fork over and top up as required to maintain minimum depth (usually 300 mm).

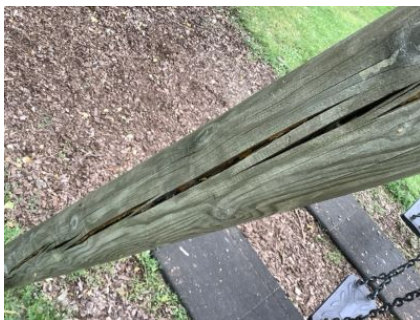
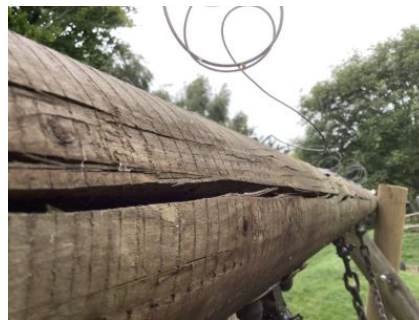
There are natural splits / shakes in the timbers.

Expanding foam has been used to seal up shakes. This is not recommended, as shakes are a natural process for timbers. As the timber naturally contracts, it could cause damage if the filler impedes the natural shrinkage.

DO NOT fill shakes. Monitor and sand back any splintered edges as required.

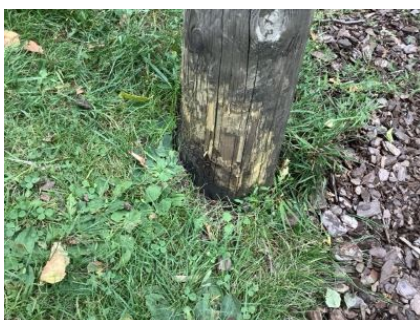
Strimmer damage is present on posts, allowing water to enter and timbers to soften. It can also remove the protective envelope around the timber. Prevent further damage and check timbers for decay throughout the year.

Prevent further damage.

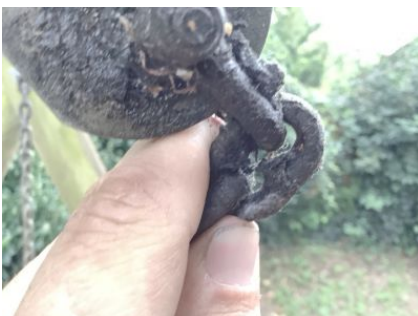
Swing - Toddler - 1 Bay 2 Seat

Some chain wear.

Monitor for further deterioration and replace before 40% wear.

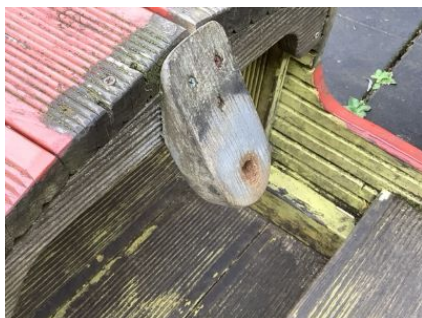
Play Feature - Aeroplane

Item has some parts missing.

Replace the missing parts.

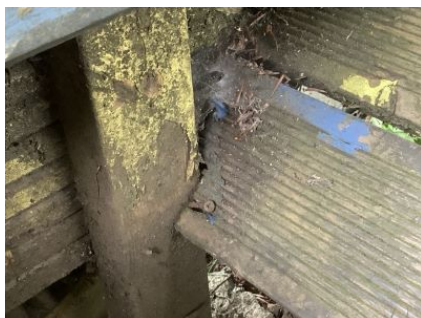
Play Feature - Train

Timber is decayed.

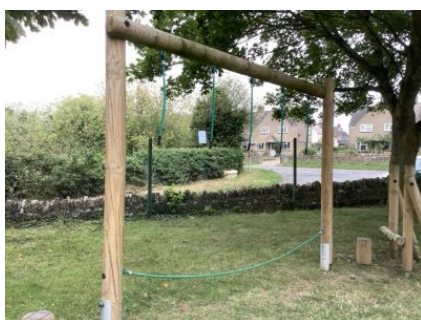
This equipment relies on one post for its stability. Special attention should be paid to maintenance (e.g. by monitoring degradation) and if necessary decommissioning the item before the end of its operating life.

Consult with the manufacturer's guidance to determine suitable maintenance.

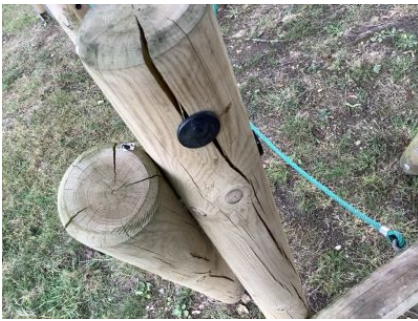
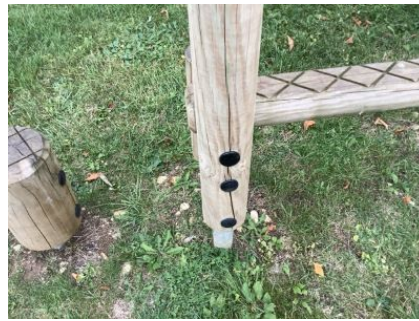
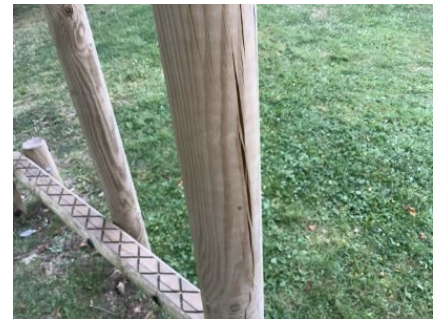
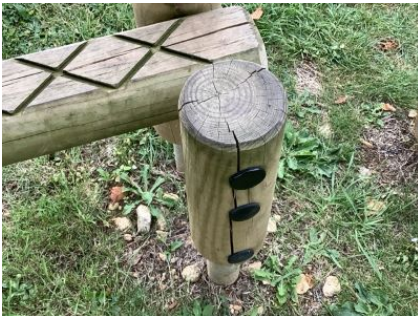
There are natural splits / shakes in the timbers.

DO NOT fill shakes. Monitor and sand back any splintered edges as required.
